Sacramento River, RM 77.2L

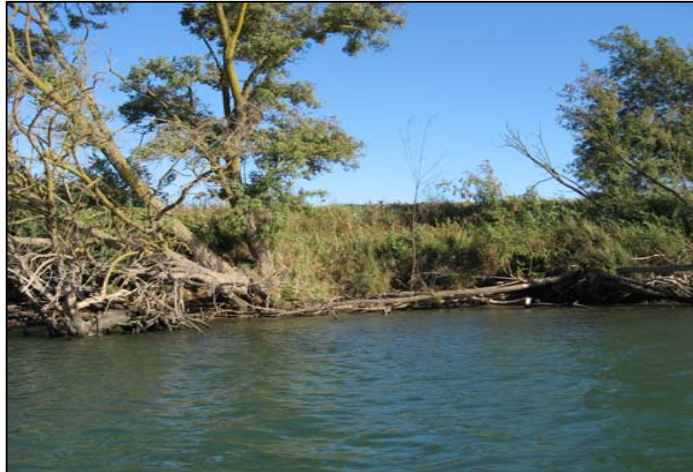
Site Photograph

Criteria	Score	Notes
Bank Slope (*2)	4	1.5:1 slope
Berm Width (*2) - Estimated	3	5 ft of berm
Length of erosion	2	159 ft
Location of erosion	2	mid and lower bank
Bank Stability	0	no stability issues
Radius of Curvature (R_c/w)	0	$R/w = 7.89$
Site Relative to Bend	3	outside of a slight bend
Geomorph	0	no migration expected
Vegetation Cover	0	90%
Tree Hazard	5	large leaning trees, exposed roots
Soil Type (*2)	4	sands and silts
Velocity (*2)	3	4.3 ft/s
Wave Action (Wind/Boat)	4	heavy, delta winds, recreational boats
Economic Factor (*2)	2	small town of Isleton
Human Usage	1	occassional, lots of veg
Seepage Potential	0	no seepage
Tidal Fluctuation	4	4 ft of tidal flux
Erosion Hazard	53	Calculate Erosion Hazard

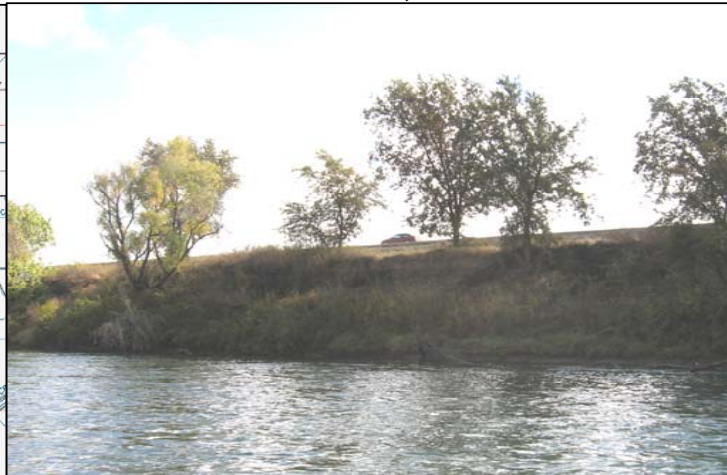
Site Photograph

Criteria	Score	Notes
Bank Slope (*2)	3	1.5:1 slope
Berm Width (*2) - Estimated	0	30 ft
Length of erosion	3	675 ft
Location of erosion	2	whole bank
Bank Stability	3	holes left from fallen trees, and erosion pockets
Radius of Curvature (R_c/w)	0	straight
Site Relative to Bend	1	straight
Geomorph	2	migration possible on opposite bank
Vegetation Cover	0	80 to 90%
Tree Hazard	4	large trees with visible roots
Soil Type (*2)	4	sands and silts
Velocity (*2)	4	7.23 ft/s
Wave Action (Wind/Boat)	3	moderate waves
Economic Factor (*2)	2	small town of Verona
Human Usage	4	Path down, a bare spot that appears to be used by humans
Seepage Potential	5	history of seepage
Tidal Fluctuation	0	no tidal flux
Erosion Hazard	53	Calculate Erosion Hazard

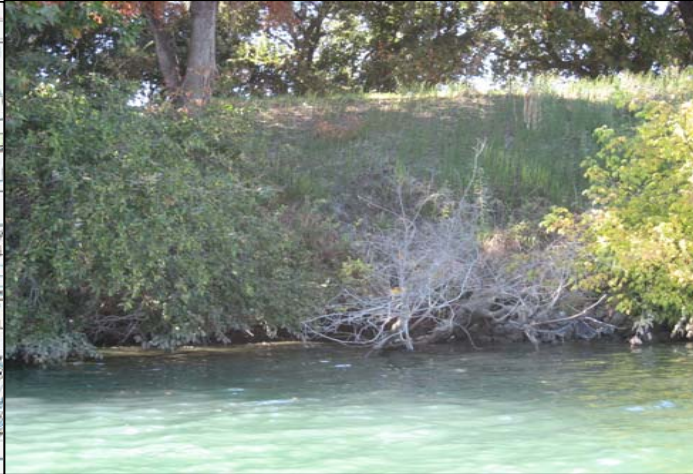
Site Photograph

Criteria	Score	Notes
Bank Slope (*2)	4	1:1 slope
Berm Width (*2) - Estimated	3	about 5 ft
Length of erosion	2	168 ft
Location of erosion	2	lower bank
Bank Stability	0	no vertical sections or caves
Radius of Curvature (R_c/w)	4	$R/w = 1.96$
Site Relative to Bend	4	outside of a 90 degree bend
Geomorph	0	no migration possible
Vegetation Cover	0	90%
Tree Hazard	4	large trees with exposed roots
Soil Type (*2)	2	clays and silts
Velocity (*2)	3	4.45 ft/s
Wave Action (Wind/Boat)	3	moderate
Economic Factor (*2)	1	Farms
Human Usage	4	weekly
Seepage Potential	0	no seepage history
Tidal Fluctuation	4	4 ft of tidal flux
Erosion Hazard	53	Calculate Erosion Hazard

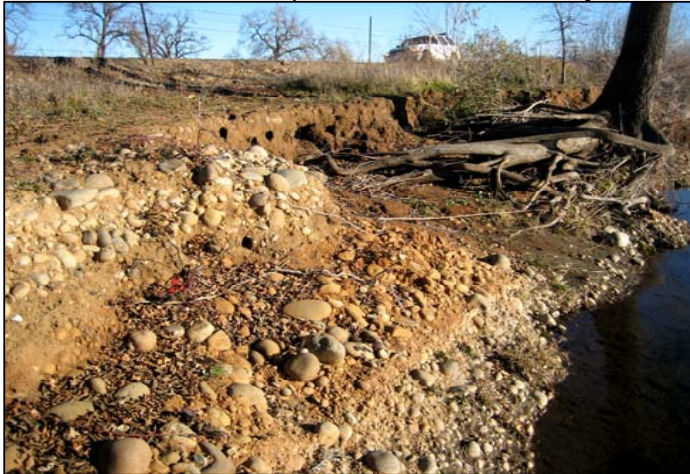
Site Photograph

Criteria	Score	Notes
Bank Slope (*2)	5	near vertical
Berm Width (*2) - Estimated	2	10 to 15 ft
Length of erosion	2	260 ft
Location of erosion	4	toe and bank
Bank Stability	5	Vertical sections, greater than half bank height and animal holes
Radius of Curvature (R_c/w)	0	$R/w = 5.25$
Site Relative to Bend	3	outside of a gentle bend
Geomorph	0	tight levees, no migration expected
Vegetation Cover	4	minimal veg
Tree Hazard	5	large leaning trees with exposed roots
Soil Type (*2)	3	sands and cobbles
Velocity (*2)	4	~5+ ft/s
Wave Action (Wind/Boat)	0	no waves
Economic Factor (*2)	1	Farms
Human Usage	0	rare
Seepage Potential	0	no known seepage history
Tidal Fluctuation	0	no tidal fux

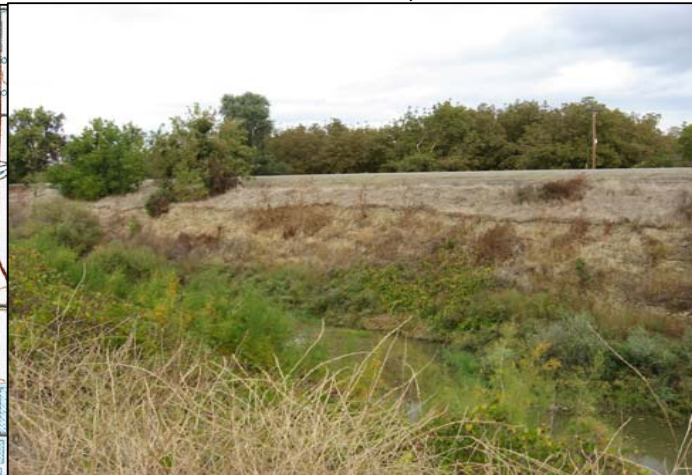
Site Photograph

Criteria	Score	Notes
Bank Slope (*2)	4	1:1 slope
Berm Width (*2) - Estimated	2	15 to 30 feet
Length of erosion	2	331 ft
Location of erosion	4	toe and upper bank
Bank Stability	5	vertical sections, less than half slope height, and caves
Radius of Curvature (R_c/w)	3	$R/w = 2.05$
Site Relative to Bend	5	outside of a less than 90 degree bend
Geomorph	0	no migration expected
Vegetation Cover	2	40%
Tree Hazard	0	no trees
Soil Type (*2)	4	sands and silts
Velocity (*2)	4	6.5 ft/s
Wave Action (Wind/Boat)	0	no wind or boats
Economic Factor (*2)	2	Small town of Yolo
Human Usage	0	adjacent to private property, rare usage
Seepage Potential	0	no seepage history
Tidal Fluctuation	0	no tidal influence
Erosion Hazard	53	Calculate Erosion Hazard

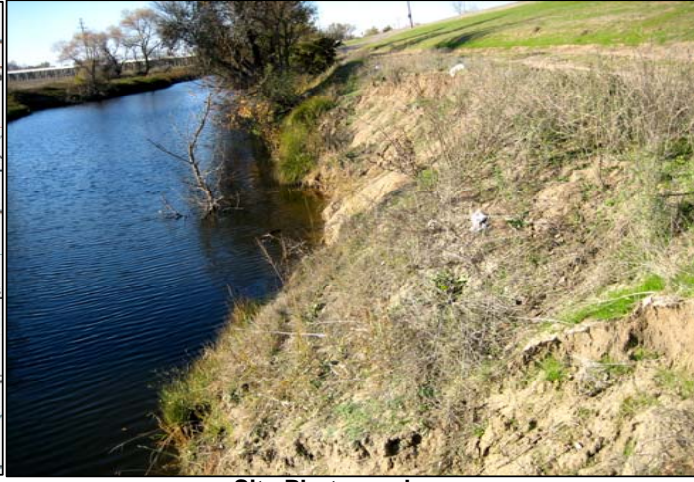
Site Photograph

Criteria	Score	Notes
Bank Slope (*2)	4	1:1 slope
Berm Width (*2) - Estimated	3	5 to 6 ft of berm
Length of erosion	1	100 ft
Location of erosion	4	toe and lower slope
Bank Stability	2	some vertical sections, less than half bank height
Radius of Curvature (R_c/w)	0	relatively straight
Site Relative to Bend	1	relatively straight
Geomorph	0	no migration expected
Vegetation Cover	3	minimal, less than 40%
Tree Hazard	2	medium sized trees
Soil Type (*2)	4	sands and silts
Velocity (*2)	2	3.0 ft/s
Wave Action (Wind/Boat)	1	occassional wind waves
Economic Factor (*2)	2	town of Sutter
Human Usage	4	near road, trash evident, weekly
Seepage Potential	5	known seepage issues in this area
Tidal Fluctuation	0	no tidal influence

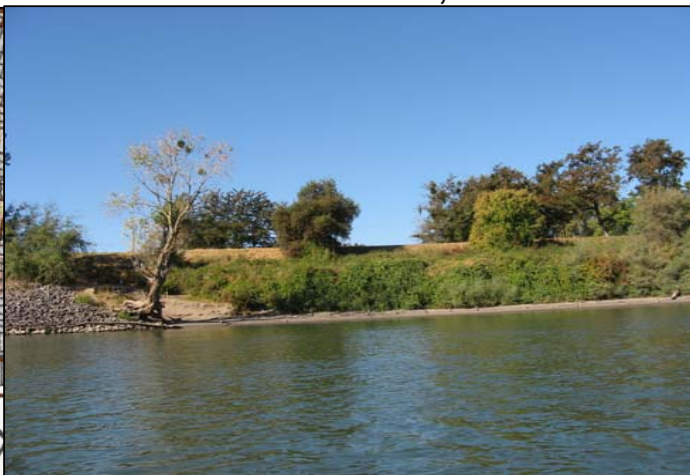
Site Photograph

Criteria	Score	Notes
Bank Slope (*2)	3	1.5:1 slope
Berm Width (*2) - Estimated	1	25 ft
Length of erosion	2	372 ft
Location of erosion	2	berm
Bank Stability	5	caves and vertical sections
Radius of Curvature (R_c/w)	0	straight
Site Relative to Bend	1	straight
Geomorph	0	no migration possible
Vegetation Cover	0	80%
Tree Hazard	4	large trees with exposed roots
Soil Type (*2)	2	clays and silts
Velocity (*2)	4	5.11 ft/s
Wave Action (Wind/Boat)	4	heavy recreation area
Economic Factor (*2)	4	West Sacramento
Human Usage	4	weekly, rope swing
Seepage Potential	0	no seepage history
Tidal Fluctuation	2	2 ft of tidal flux

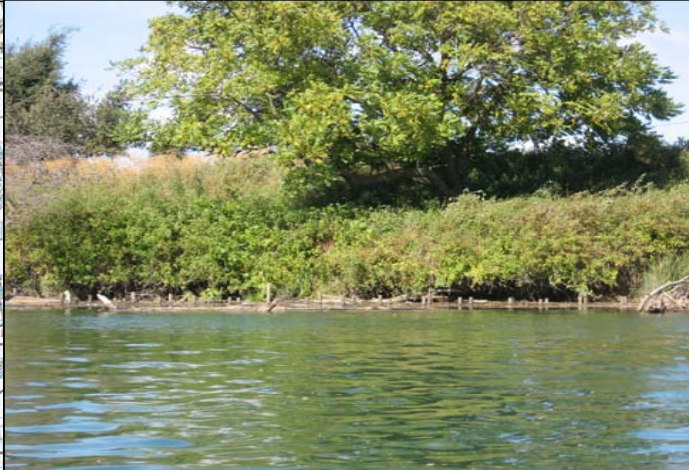
Site Photograph

Criteria	Score	Notes
Bank Slope (*2)	4	1:1 slope
Berm Width (*2) - Estimated	2	10 ft
Length of erosion	4	1019 ft
Location of erosion	3	whole bank
Bank Stability	2	vertical sections, less than half bank height
Radius of Curvature (R_c/w)	4	$R/w = 1.75$
Site Relative to Bend	5	outside of a sharp bend
Geomorph	0	no migration possible
Vegetation Cover	0	85%
Tree Hazard	2	medium trees
Soil Type (*2)	4	silts and sands
Velocity (*2)	1	1.07 ft/s
Wave Action (Wind/Boat)	2	low, 5 MPH
Economic Factor (*2)	1	Farms
Human Usage	2	thick vegetation, seasonal
Seepage Potential	0	no seepage history
Tidal Fluctuation	4	4 ft of tidal flux

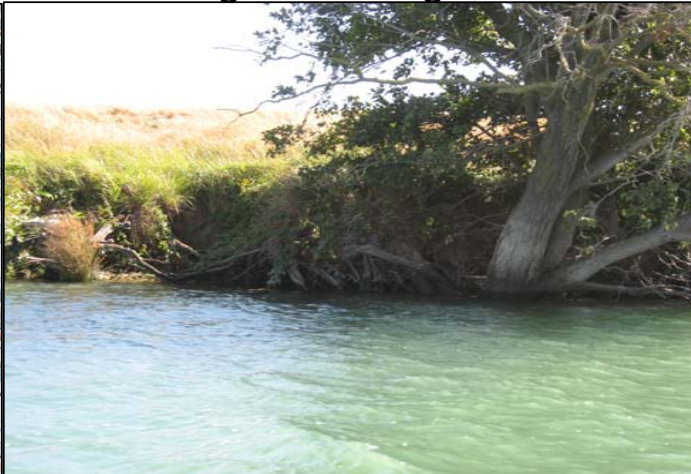
Site Photograph

Criteria	Score	Notes
Bank Slope (*2)	4	1:1 slope
Berm Width (*2) - Estimated	2	10 ft
Length of erosion	2	348 ft
Location of erosion	2	lower bank
Bank Stability	5	caves greater than 4 ft and vertical sections
Radius of Curvature (R_c/w)	0	straight
Site Relative to Bend	1	straight
Geomorph	0	no migration possible
Vegetation Cover	4	70%
Tree Hazard	1	young trees
Soil Type (*2)	4	sands and silts
Velocity (*2)	3	3.77 ft/s
Wave Action (Wind/Boat)	3	moderate boat wake
Economic Factor (*2)	1	Farms
Human Usage	2	seasonal
Seepage Potential	0	no seepage history
Tidal Fluctuation	4	4 ft of tidal flux

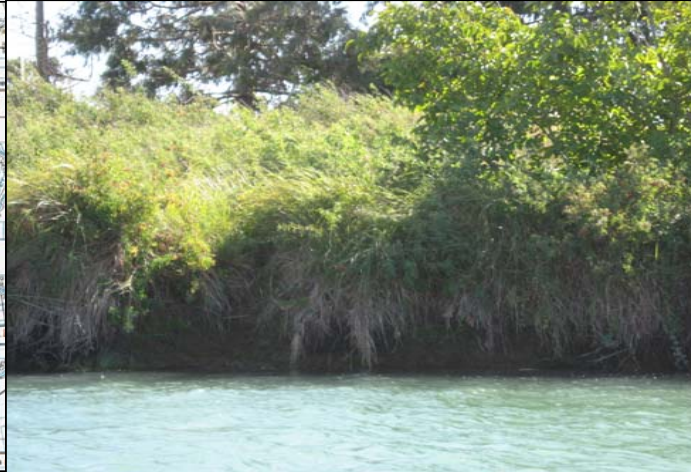
Site Photograph

Criteria	Score	Notes
Bank Slope (*2)	3	1.5:1 slope
Berm Width (*2) - Estimated	2	10 ft
Length of erosion	5	1707 ft
Location of erosion	4	berm slope and toe
Bank Stability	1	caves
Radius of Curvature (R_c/w)	0	$R/w = 9.66$
Site Relative to Bend	3	outside of a gentle bend
Geomorph	0	no migration possible
Vegetation Cover	0	80 to 90%
Tree Hazard	4	large trees with exposed roots
Soil Type (*2)	4	sands and silts
Velocity (*2)	3	3.95 ft/s
Wave Action (Wind/Boat)	3	moderate boat wake
Economic Factor (*2)	1	Farms
Human Usage	2	seasonal
Seepage Potential	0	no seepage history
Tidal Fluctuation	4	4 ft of tidal flux

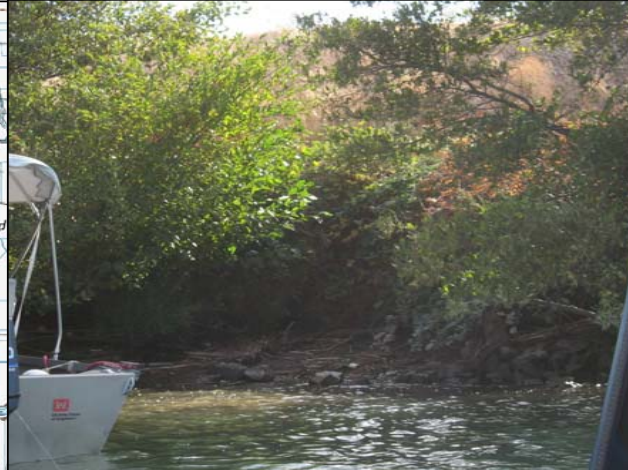
Site Photograph

Criteria	Score	Notes
Bank Slope (*2)	2	2:1 slope
Berm Width (*2) - Estimated	4	3 to 6 ft
Length of erosion	2	182 ft
Location of erosion	3	toe
Bank Stability	5	vertical sections, less than half bank height, beaver burrows
Radius of Curvature (R_c/w)	0	straight
Site Relative to Bend	2	just downstream of a bend
Geomorph	0	tight levees, no migration expected
Vegetation Cover	2	about 40%
Tree Hazard	0	no trees
Soil Type (*2)	1	clays
Velocity (*2)	5	10.9 ft/s
Wave Action (Wind/Boat)	5	Heavy, cargo ships passing
Economic Factor (*2)	1	Farms
Human Usage	3	monthly
Seepage Potential	0	no seepage history
Tidal Fluctuation	4	About 4 ft of tidal flux
Erosion Hazard	52	Calculate Erosion Hazard

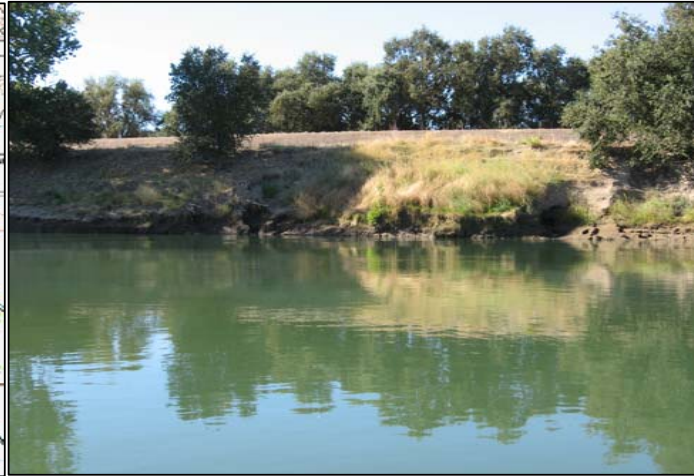
Site Photograph

Criteria	Score	Notes
Bank Slope (*2)	3	1.5:1 slope
Berm Width (*2) - Estimated	0	30 ft
Length of erosion	2	246 ft
Location of erosion	4	bank and toe
Bank Stability	5	vertical sections , greater than half bank height and caves
Radius of Curvature (R_c/w)	0	straight
Site Relative to Bend	2	just downstream from a bend
Geomorph	0	no migration possible
Vegetation Cover	4	20%
Tree Hazard	5	trees with exposed roots and leaning
Soil Type (*2)	2	clays and silts
Velocity (*2)	4	5.17 ft/s
Wave Action (Wind/Boat)	2	moderate
Economic Factor (*2)	3	rural town of Colusa
Human Usage	3	monthly
Seepage Potential	0	no seepage history
Tidal Fluctuation	0	no tidal influence
Erosion Hazard	51	Calculate Erosion Hazard

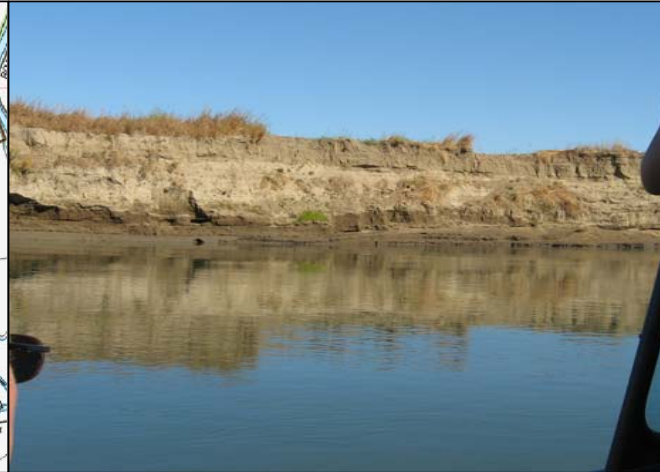
Site Photograph

Criteria	Score	Notes
Bank Slope (*2)	5	near vertical
Berm Width (*2) - Estimated	0	40 to 50 ft
Length of erosion	5	1534 ft
Location of erosion	4	full bank and toe
Bank Stability	5	vertical sections greater than half bank height, and animal holes
Radius of Curvature (R_c/w)	0	$R/w = 6.98$
Site Relative to Bend	0	inside of a bend
Geomorph	0	no migration expected
Vegetation Cover	4	10%
Tree Hazard	4	trees with exposed roots, one freshly fallen
Soil Type (*2)	4	sands and silts
Velocity (*2)	3	3.18 ft/s
Wave Action (Wind/Boat)	2	moderate
Economic Factor (*2)	1	Farms
Human Usage	1	occassional
Seepage Potential	0	no history of seepage
Tidal Fluctuation	0	no tidal influence
Erosion Hazard	51	Calculate Erosion Hazard

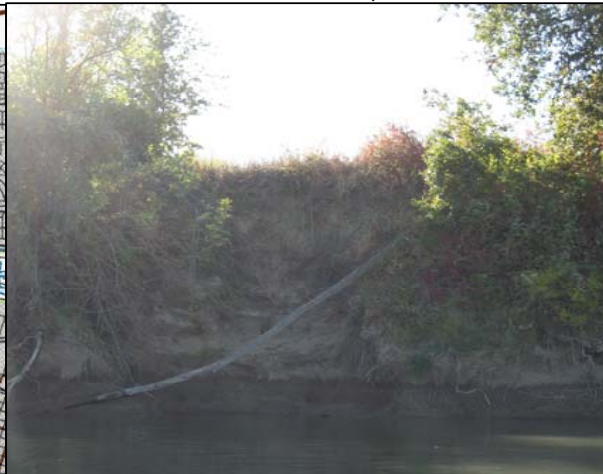
Site Photograph

Sacramento River, RM 63.0R

Criteria	Score	Notes
Bank Slope (*2)	3	1.5:1 slope
Berm Width (*2) - Estimated	2	less than 20 ft
Length of erosion	1	100 ft
Location of erosion	3	toe
Bank Stability	2	vertical sections, less than half bank height
Radius of Curvature (R_c/w)	0	straight
Site Relative to Bend	1	straight
Geomorph	0	no migration possible
Vegetation Cover	3	30%
Tree Hazard	5	large trees, exposed roots, some leaning
Soil Type (*2)	2	clays and silts
Velocity (*2)	2	2.87 ft/s
Wave Action (Wind/Boat)	4	marina and boat launch near, heavy recreational boating area
Economic Factor (*2)	4	West Sacramento
Human Usage	5	stairs down to bank, daily
Seepage Potential	0	no seepage history
Tidal Fluctuation	1	1 ft of tidal flux
Erosion Hazard	51	Calculate Erosion Hazard

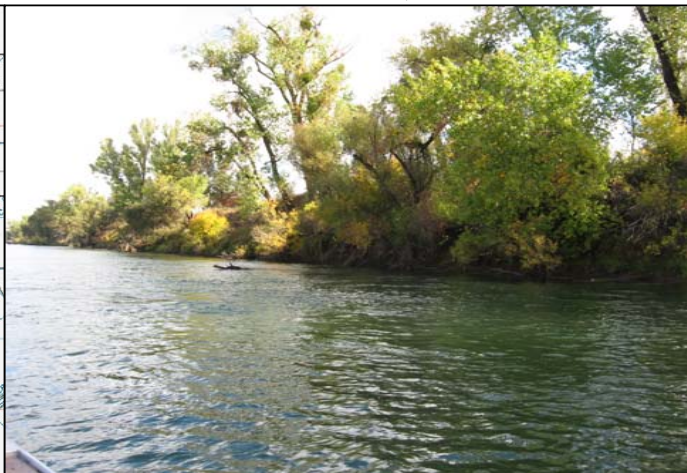
Site Photograph

Feather River, RM 4.9L

Criteria	Score	Notes
Bank Slope (*2)	3	1.5:1 slope
Berm Width (*2) - Estimated	0	greater than 30 ft
Length of erosion	3	909 ft
Location of erosion	1	berm
Bank Stability	0	no vertical sections or burrows
Radius of Curvature (R_c/w)	0	straight
Site Relative to Bend	1	straight
Geomorph	2	migration possible on opposite bank
Vegetation Cover	1	60 to 70% cover
Tree Hazard	4	trees with visible roots
Soil Type (*2)	4	sands and silts
Velocity (*2)	5	8.79 ft/s
Wave Action (Wind/Boat)	3	moderate waves
Economic Factor (*2)	2	small town of Verona
Human Usage	3	monthly
Seepage Potential	5	history of seepage
Tidal Fluctuation	0	no tidal flux
Erosion Hazard	51	Calculate Erosion Hazard

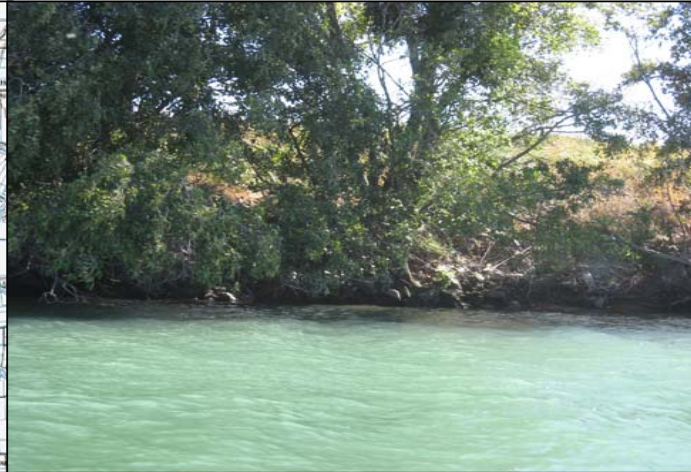
Site Photograph

Georgiana Slough, RM 8.3L

Criteria	Score	Notes
Bank Slope (*2)	3	1.5:1 slope
Berm Width (*2) - Estimated	2	15 ft
Length of erosion	1	81 ft
Location of erosion	2	middle and lower bank
Bank Stability	4	vertical sections, greater than half bank height
Radius of Curvature (R_c/w)	2	$R/w = 3.96$
Site Relative to Bend	4	outside of a 90 degree bend
Geomorph	0	no migration possible
Vegetation Cover	1	80%
Tree Hazard	0	no trees
Soil Type (*2)	4	sands and silts
Velocity (*2)	3	3.68 ft/s
Wave Action (Wind/Boat)	3	5 MPH zone, but windy
Economic Factor (*2)	1	Farms
Human Usage	4	adjacent to public road, debris, weekly
Seepage Potential	0	no seepage history
Tidal Fluctuation	4	4 ft of tidal flux
Erosion Hazard	51	Calculate Erosion Hazard

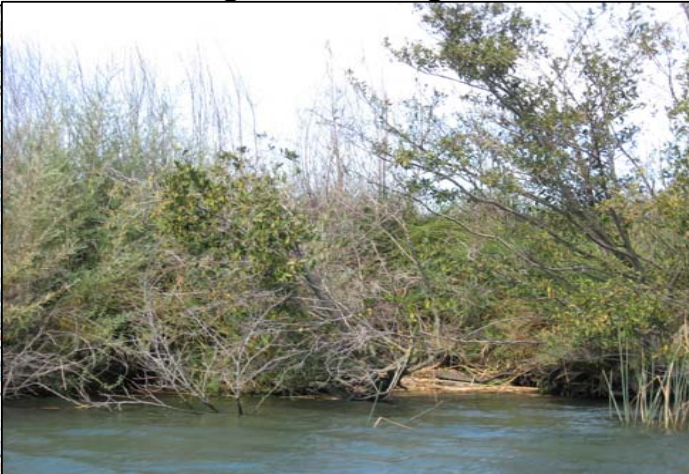
Site Photograph

Georgiana Slough, RM 0.3L

Criteria	Score	Notes
Bank Slope (*2)	3	1.5:1 slope
Berm Width (*2) - Estimated	4	less than 5 ft
Length of erosion	4	1225 ft
Location of erosion	4	toe and levee slope
Bank Stability	0	no vertical sections or caves
Radius of Curvature (R_c/w)	0	$R/w = 13.8$
Site Relative to Bend	3	outside of a slight bend
Geomorph	0	no migration possible
Vegetation Cover	0	about 90%
Tree Hazard	0	small trees
Soil Type (*2)	4	sands and silts
Velocity (*2)	3	4.63 ft/s
Wave Action (Wind/Boat)	4	5 MPH zone, but heavy wind
Economic Factor (*2)	1	Farms
Human Usage	2	one path down with grass growing over it, seasonal use
Seepage Potential	0	no seepage history
Tidal Fluctuation	4	About 4 ft of flux

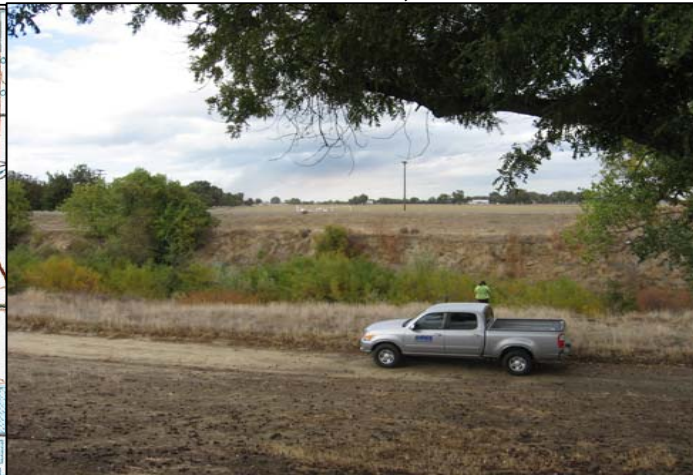
Site Photograph

Cache Creek, LM 3.9L

Criteria	Score	Notes
Bank Slope (*2)	4	less than 1:1
Berm Width (*2) - Estimated	2	10 to 25 ft
Length of erosion	2	430 ft
Location of erosion	4	whole bank and toe
Bank Stability	5	vertical sections and caves
Radius of Curvature (R_c/w)	0	straight
Site Relative to Bend	1	straight
Geomorph	0	no migration possible
Vegetation Cover	3	30%
Tree Hazard	4	large trees with exposed roots
Soil Type (*2)	4	sands and silts
Velocity (*2)	4	6 ft/s
Wave Action (Wind/Boat)	0	none
Economic Factor (*2)	2	small town of Yolo
Human Usage	0	rare
Seepage Potential	0	no known history
Tidal Fluctuation	0	no tidal flux
Erosion Hazard	51	Calculate Erosion Hazard

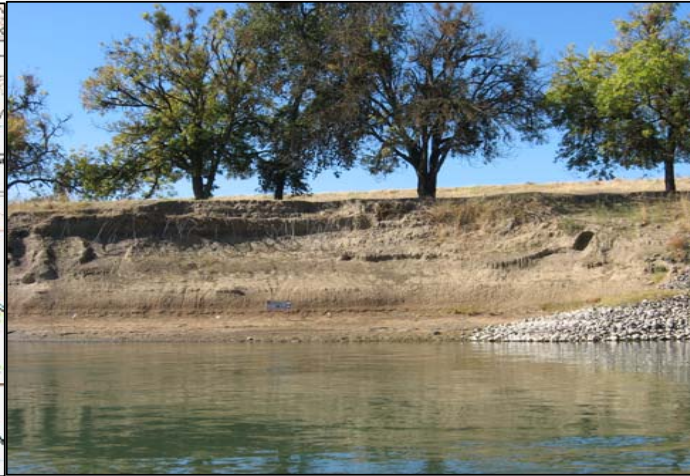
Site Photograph

Sacramento River, RM 136.9R

Criteria	Score	Notes
Bank Slope (*2)	4	1:1 slope
Berm Width (*2) - Estimated	0	30 ft
Length of erosion	2	289 ft
Location of erosion	4	whole bank and toe
Bank Stability	5	vertical sections less than half bank height and caves
Radius of Curvature (R_c/w)	0	straight
Site Relative to Bend	2	just downstream from a bend
Geomorph	0	no migration possible
Vegetation Cover	4	20%
Tree Hazard	4	large trees with exposed roots
Soil Type (*2)	2	clays and silts
Velocity (*2)	3	4.66 ft/s
Wave Action (Wind/Boat)	2	low
Economic Factor (*2)	3	rural town of Colusa
Human Usage	3	monthly
Seepage Potential	0	no seepage history
Tidal Fluctuation	0	no tidal influence
Erosion Hazard	50	Calculate Erosion Hazard

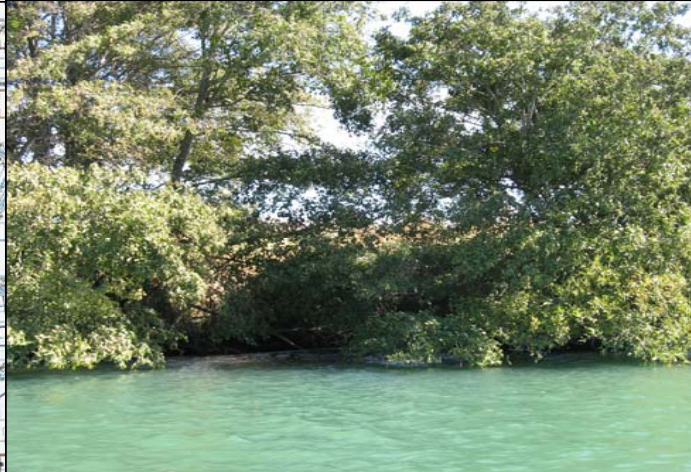
Site Photograph

Georgiana Slough, RM 4.5L

Criteria	Score	Notes
Bank Slope (*2)	3	1.5:1 slope
Berm Width (*2) - Estimated	4	less than 5 ft
Length of erosion	2	150 ft
Location of erosion	3	toe
Bank Stability	2	some vertical sections, less than half bank height
Radius of Curvature (R_c/w)	0	straight
Site Relative to Bend	1	straight
Geomorph	0	no migration possible
Vegetation Cover	0	dense, 95%
Tree Hazard	5	trees with exposed roots and leaning
Soil Type (*2)	4	sands and silts
Velocity (*2)	3	4.01 ft/s
Wave Action (Wind/Boat)	3	moderate boat wake
Economic Factor (*2)	1	Farms
Human Usage	0	too dense with vegetation for human use
Seepage Potential	0	no seepage history
Tidal Fluctuation	4	4 ft of tidal flux

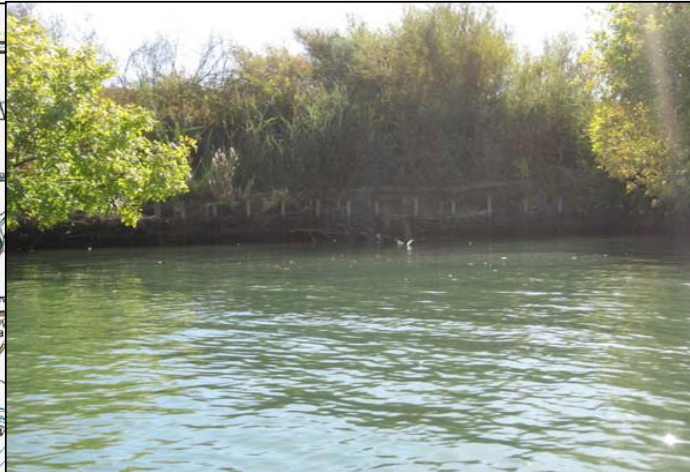
Site Photograph

Sacramento River, RM 25.2L

Criteria	Score	Notes
Bank Slope (*2)	4	1:1 slope
Berm Width (*2) - Estimated	2	10 ft
Length of erosion	2	304 ft
Location of erosion	2	berm slope
Bank Stability	2	vertical sections, less than half bank height
Radius of Curvature (R_c/w)	0	straight
Site Relative to Bend	1	straight
Geomorph	0	no migration expected
Vegetation Cover	1	80%
Tree Hazard	4	large trees with exposed roots
Soil Type (*2)	2	clays and silts
Velocity (*2)	3	4.54 ft/s
Wave Action (Wind/Boat)	4	heavy
Economic Factor (*2)	2	small town of Isleton
Human Usage	3	monthly, some debris
Seepage Potential	0	no seepage
Tidal Fluctuation	4	4 ft of tidal flux
Erosion Hazard	49	Calculate Erosion Hazard

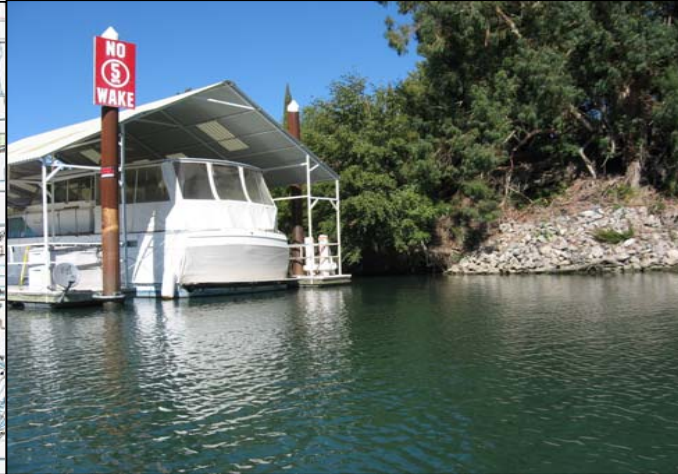
Site Photograph

Steamboat Slough, RM 23.2L

Criteria	Score	Notes
Bank Slope (*2)	3	1.5:1 slope
Berm Width (*2) - Estimated	5	no berm
Length of erosion	2	178 ft
Location of erosion	2	whole bank
Bank Stability	0	no vertical sections or caves
Radius of Curvature (R_c/w)	0	$R/w = 9.34$
Site Relative to Bend	0	inside of a bend
Geomorph	0	no migration possible
Vegetation Cover	1	60%
Tree Hazard	5	leaning trees
Soil Type (*2)	2	clays and silts
Velocity (*2)	3	4.66 ft/s
Wave Action (Wind/Boat)	3	moderate
Economic Factor (*2)	1	Farms
Human Usage	4	weekly
Seepage Potential	0	no seepage history
Tidal Fluctuation	4	4 ft of tidal flux
Erosion Hazard	49	Calculate Erosion Hazard

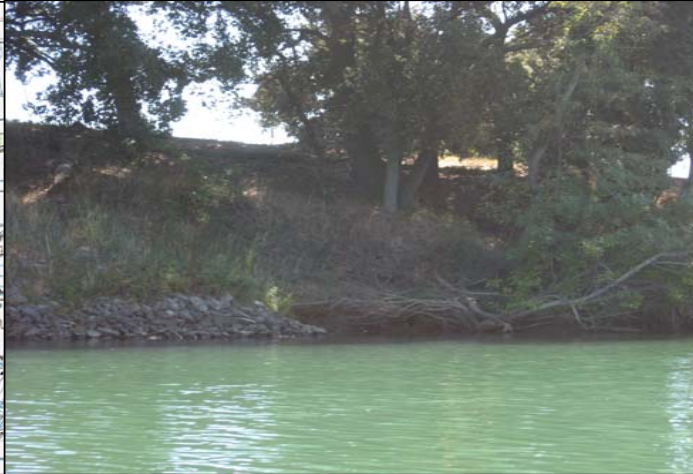
Site Photograph

Criteria	Score	Notes
Bank Slope (*2)	3	1.5:1 slope
Berm Width (*2) - Estimated	3	5 ft
Length of erosion	2	317 ft
Location of erosion	4	lower bank and toe
Bank Stability	1	caves from tree popouts
Radius of Curvature (R_c/w)	0	$R/w = 6.72$
Site Relative to Bend	0	inside of a bend
Geomorph	0	no migration possible
Vegetation Cover	3	40%
Tree Hazard	5	large trees, exposed roots and leaning
Soil Type (*2)	2	clays and silts
Velocity (*2)	3	4.76 ft/s
Wave Action (Wind/Boat)	3	moderate
Economic Factor (*2)	1	Farms
Human Usage	3	monthly
Seepage Potential	0	no seepage history
Tidal Fluctuation	4	4 ft of tidal flux
Erosion Hazard	49	Calculate Erosion Hazard

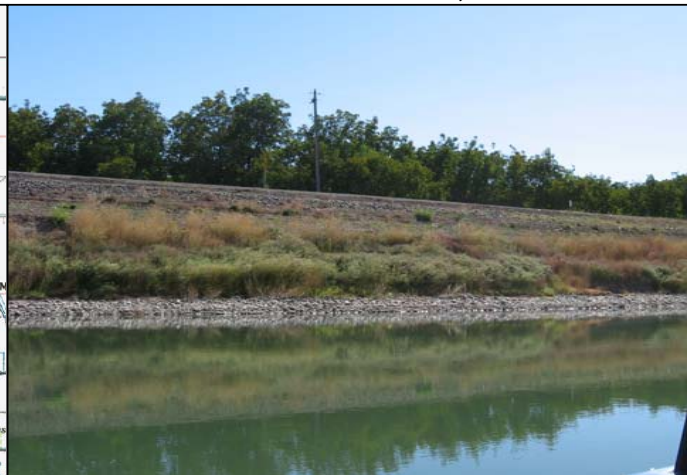
Site Photograph

Sacramento River, RM 92.8L

Criteria	Score	Notes
Bank Slope (*2)	2	2:1 slope
Berm Width (*2) - Estimated	5	0 to 15 ft
Length of erosion	4	1106 ft
Location of erosion	3	toe
Bank Stability	0	short vertical sections
Radius of Curvature (R_c/w)	3	$R/w = 2.22$
Site Relative to Bend	2	just downstream of a bend
Geomorph	0	no migration expected
Vegetation Cover	1	60%
Tree Hazard	0	no trees
Soil Type (*2)	4	sands and silts
Velocity (*2)	3	3.32 ft/s
Wave Action (Wind/Boat)	2	moderate
Economic Factor (*2)	1	Farms
Human Usage	3	monthly
Seepage Potential	0	no seepage history
Tidal Fluctuation	0	no tidal influence
Erosion Hazard	48	Calculate Erosion Hazard

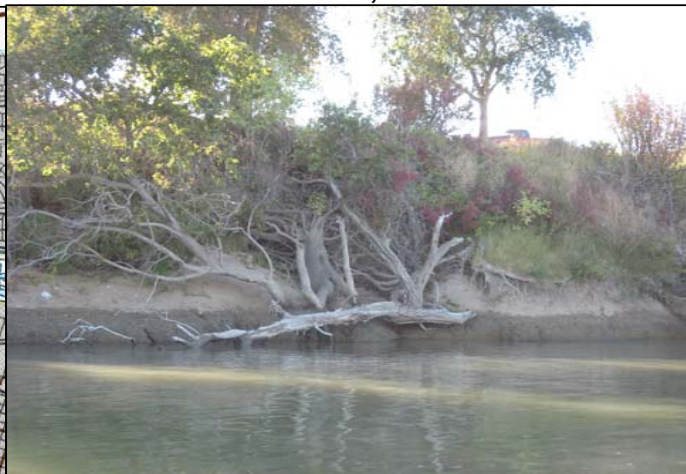
Site Photograph

Sacramento River, RM 62.9R

Criteria	Score	Notes
Bank Slope (*2)	3	1.5:1 slope
Berm Width (*2) - Estimated	2	less than 20 ft
Length of erosion	2	178 ft
Location of erosion	3	toe
Bank Stability	2	vertical sections, less than halfbank height
Radius of Curvature (R_c/w)	0	straight
Site Relative to Bend	1	straight
Geomorph	0	no migration possible
Vegetation Cover	1	80%
Tree Hazard	4	large trees with exposed roots
Soil Type (*2)	2	clays and silts
Velocity (*2)	3	3.08 ft/s
Wave Action (Wind/Boat)	4	marina and boat launch near, heavy recreational boating area
Economic Factor (*2)	4	West Sacramento
Human Usage	2	heavy veg, seasonal
Seepage Potential	0	no seepage history
Tidal Fluctuation	1	1 ft of tidal flux
Erosion Hazard	48	Calculate Erosion Hazard

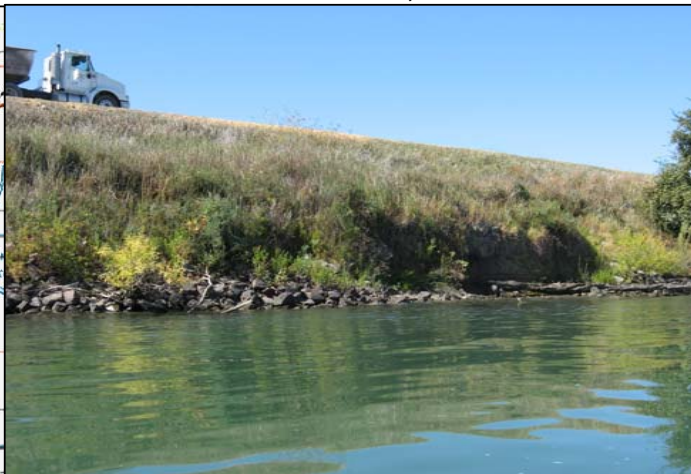
Site Photograph

Sacramento River, RM 38.5R

Criteria	Score	Notes
Bank Slope (*2)	3	1.5:1 slope
Berm Width (*2) - Estimated	4	less than 5 ft
Length of erosion	2	360 ft
Location of erosion	4	lower bank and toe
Bank Stability	2	vertical sections, less than half bank slope
Radius of Curvature (R_c/w)	0	straight
Site Relative to Bend	1	straight
Geomorph	0	no migration expected
Vegetation Cover	2	40-50%
Tree Hazard	0	no trees
Soil Type (*2)	2	clays and silts
Velocity (*2)	4	5.46 ft/s
Wave Action (Wind/Boat)	3	moderate
Economic Factor (*2)	1	Farms
Human Usage	3	monthly
Seepage Potential	0	no seepage history
Tidal Fluctuation	3	3 ft of tidal flux
Erosion Hazard	48	Calculate Erosion Hazard

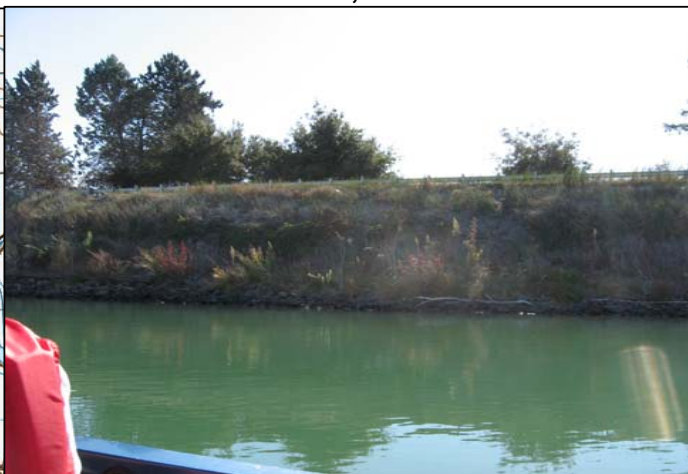
Site Photograph

Sacramento River, RM 31.6R

Criteria	Score	Notes
Bank Slope (*2)	3	1.5:1 slope
Berm Width (*2) - Estimated	5	no berm
Length of erosion	2	442 ft
Location of erosion	1	levee slope
Bank Stability	0	no vertical sections or caves
Radius of Curvature (R_c/w)	0	straight
Site Relative to Bend	1	straight
Geomorph	0	no migration possible
Vegetation Cover	1	70%
Tree Hazard	0	no trees
Soil Type (*2)	4	sands and silts
Velocity (*2)	4	5.23 ft/s
Wave Action (Wind/Boat)	3	moderate
Economic Factor (*2)	1	Farms
Human Usage	3	adjacent to road but no paths, monthly
Seepage Potential	0	no seepage history
Tidal Fluctuation	3	3 ft of tidal flux
Erosion Hazard	48	Calculate Erosion Hazard

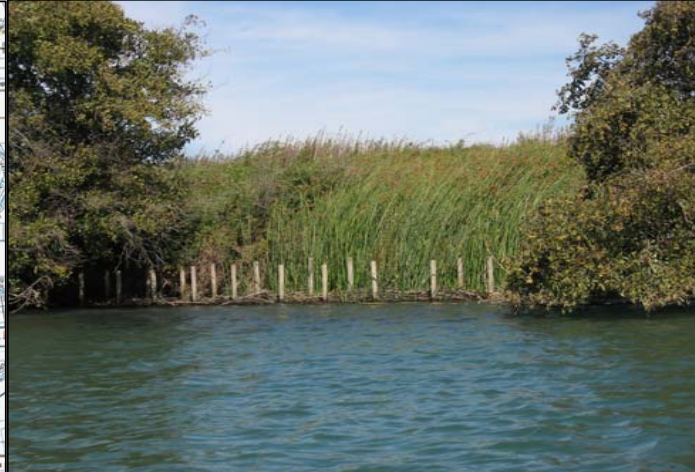
Site Photograph

Georgiana Slough, RM 1.7L

Criteria	Score	Notes
Bank Slope (*2)	2	2:1 slope
Berm Width (*2) - Estimated	4	less than 5 ft
Length of erosion	4	1365 ft
Location of erosion	3	toe
Bank Stability	3	beaver burrows, greater than 4 ft
Radius of Curvature (R_c/w)	0	straight
Site Relative to Bend	1	straight
Geomorph	0	no migration possible
Vegetation Cover	0	95%
Tree Hazard	2	medium trees
Soil Type (*2)	4	sands and silts
Velocity (*2)	3	4.05 ft/s
Wave Action (Wind/Boat)	3	moderate boat wake
Economic Factor (*2)	1	Farms
Human Usage	0	Vegetation too dense for human access
Seepage Potential	0	no seepage history
Tidal Fluctuation	4	4 ft of tidal flux
Erosion Hazard	48	Calculate Erosion Hazard

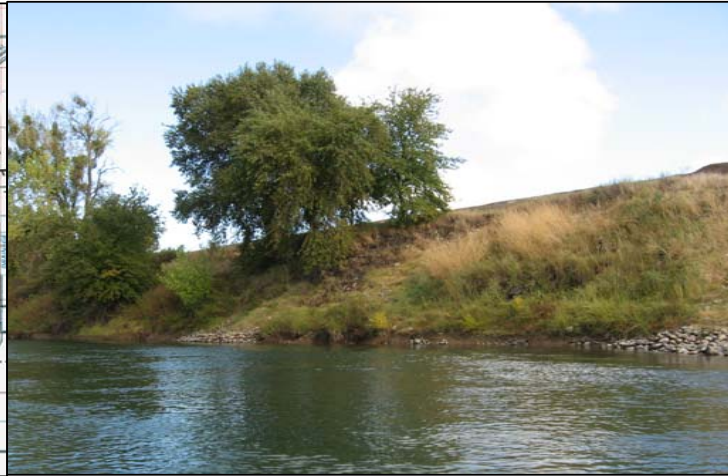
Site Photograph

Feather River, RM 0.6L

Criteria	Score	Notes
Bank Slope (*2)	1	2.5:1 slope
Berm Width (*2) - Estimated	2	15 ft
Length of erosion	2	163 ft
Location of erosion	3	toe
Bank Stability	0	no vertical sections or caves/burrows
Radius of Curvature (R_c/w)	0	straight
Site Relative to Bend	1	straight
Geomorph	2	migration possible on opposite bank
Vegetation Cover	1	about 60 to 70%
Tree Hazard	4	large trees with visible roots
Soil Type (*2)	3	Sands
Velocity (*2)	3	4.8 ft/s
Wave Action (Wind/Boat)	3	Moderate wave action
Economic Factor (*2)	2	near the town of Verona
Human Usage	5	multiple paths seen down to river, daily usage
Seepage Potential	5	seepage history
Tidal Fluctuation	0	no tidal influence
Erosion Hazard	48	Calculate Erosion Hazard

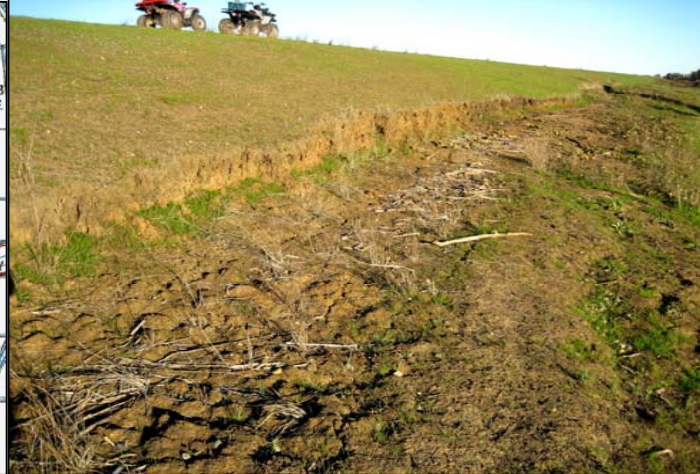
Site Photograph

Willow Slough, LM 6.9 (DWR Unit 2 South)

Criteria	Score	Notes
Bank Slope (*2)	2	2:1 slope
Berm Width (*2) - Estimated	5	no berm
Length of erosion	3	700 ft
Location of erosion	2	lower levee slope
Bank Stability	2	vertical sections, less than half bank height
Radius of Curvature (R_c/w)	3	$R/w = 2.27$
Site Relative to Bend	4	outside of a 90 degree bend
Geomorph	0	no migration expected
Vegetation Cover	3	poorly seeded grass
Tree Hazard	0	no trees
Soil Type (*2)	2	clays and silts
Velocity (*2)	0	0.2 ft/s
Wave Action (Wind/Boat)	3	moderate wave action
Economic Factor (*2)	4	City of Davis
Human Usage	2	seasonal for duck hunting
Seepage Potential	0	no known seepage history
Tidal Fluctuation	0	no tidal influence
Erosion Hazard	48	Calculate Erosion Hazard

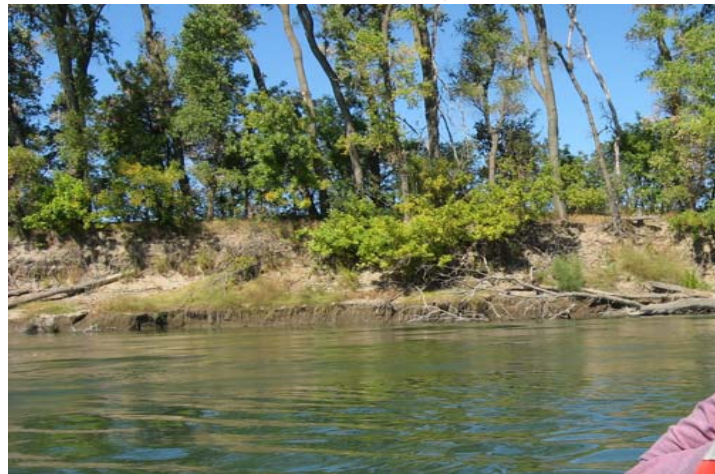
Site Photograph

Sacramento River, RM 114.5R

Criteria	Score	Notes
Bank Slope (*2)	4	1:1 slope
Berm Width (*2) - Estimated	0	30 ft
Length of erosion	2	188 ft
Location of erosion	4	bank and toe
Bank Stability	4	vertical sections, greater than half bank height
Radius of Curvature (R_c/w)	0	straight
Site Relative to Bend	1	straight
Geomorph	0	no migration possible
Vegetation Cover	4	10%
Tree Hazard	5	large trees with exposed roots, some leaning
Soil Type (*2)	4	sands and silts
Velocity (*2)	3	4.3 ft/s
Wave Action (Wind/Boat)	2	moderate
Economic Factor (*2)	1	Farms
Human Usage	1	occassional
Seepage Potential	0	no seepage history
Tidal Fluctuation	0	no tidal influence
Erosion Hazard	47	Calculate Erosion Hazard

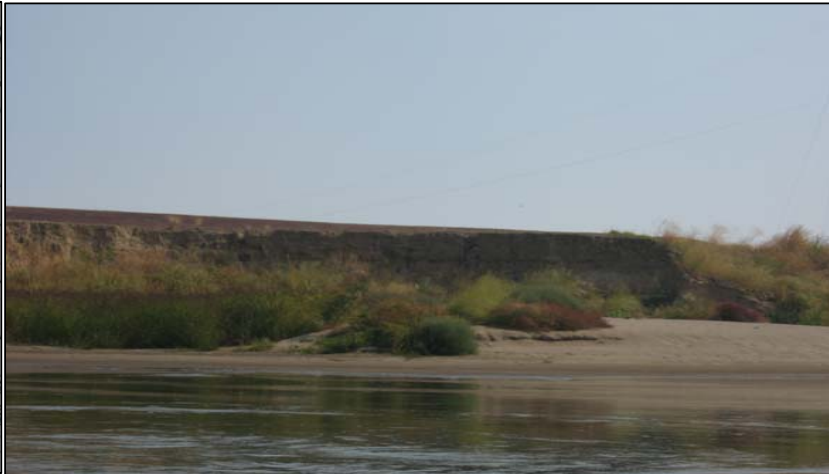
Site Photograph

Sacramento River, RM 103.4L

Criteria	Score	Notes
Bank Slope (*2)	4	1:1 to 1.5:1 slopes
Berm Width (*2) - Estimated	1	25 ft
Length of erosion	1	85 ft
Location of erosion	4	full bnak and toe
Bank Stability	2	vertical sections, full bank height
Radius of Curvature (R_c/w)	4	$R/w = 1.09$
Site Relative to Bend	0	inside of a bend
Geomorph	2	migration possible on opposite bank
Vegetation Cover	3	25%
Tree Hazard	0	no trees
Soil Type (*2)	4	sands and silts
Velocity (*2)	4	3.52 ft/s, plus eddy
Wave Action (Wind/Boat)	2	moderate
Economic Factor (*2)	1	Farms
Human Usage	1	occassional
Seepage Potential	0	no seepage history
Tidal Fluctuation	0	no tidal influence
Erosion Hazard	47	Calculate Erosion Hazard

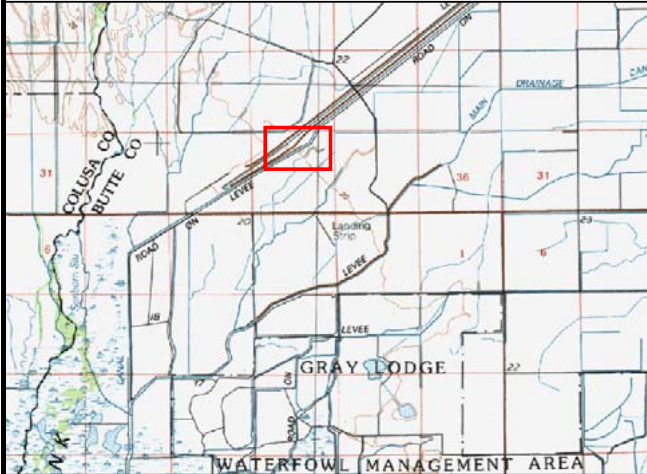
Site Location Map

Cherokee Canal, LM 21.9 (DWR MA13 Unit 2 East)

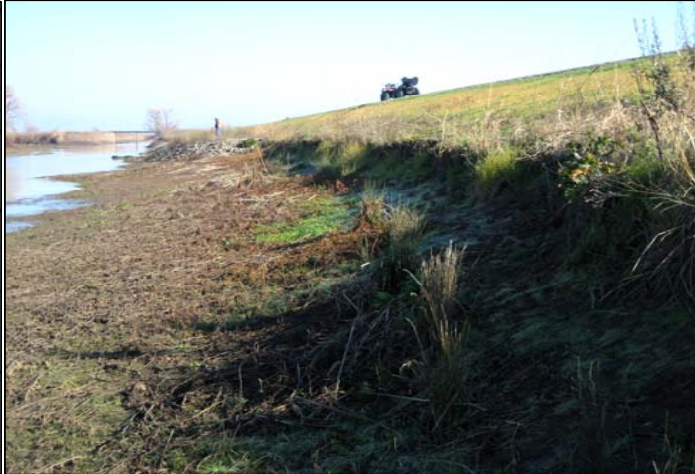
Site Photograph

Criteria	Score	Notes
Bank Slope (*2)	1	2.5:1 slope
Berm Width (*2) - Estimated	5	no berm
Length of erosion	5	1875 ft long
Location of erosion	3	toe
Bank Stability	2	vertical slope sections less than half bank height
Radius of Curvature (R_c/w)	0	straight
Site Relative to Bend	1	straight
Geomorph	0	no migration expected
Vegetation Cover	1	grass and twigs, likely burned annually, 60% cover
Tree Hazard	0	no trees
Soil Type (*2)	2	silts and clays
Velocity (*2)	4	6 ft/s
Wave Action (Wind/Boat)	3	wave wash from private damming
Economic Factor (*2)	2	small town of Biggs
Human Usage	1	occassional
Seepage Potential	0	no seepage history
Tidal Fluctuation	0	no tidal influence

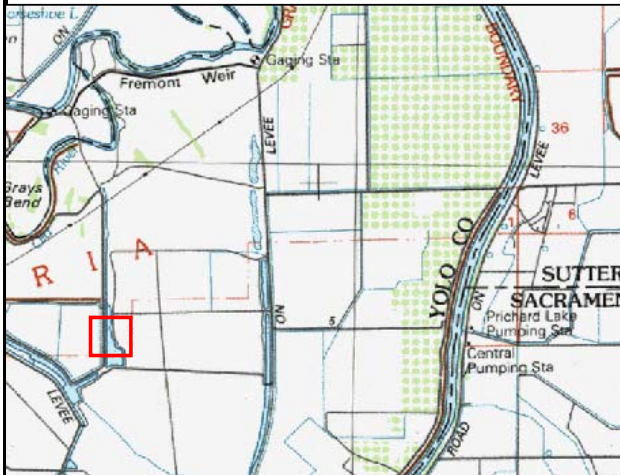
Site Location Map

Yolo Bypass, LM 2.5 (DWR Unit 1 West)

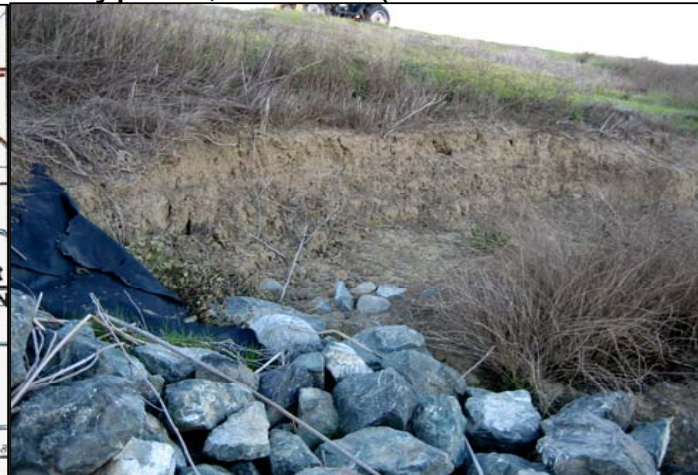
Site Photograph

Criteria	Score	Notes
Bank Slope (*2)	2	2:1 slope
Berm Width (*2) - Estimated	5	no berm
Length of erosion	1	100 ft
Location of erosion	4	toe and lower slope
Bank Stability	4	vertical sections about half bank height
Radius of Curvature (R_c/w)	0	straight
Site Relative to Bend	1	straight
Geomorph	0	no migration expected
Vegetation Cover	2	50%
Tree Hazard	0	no trees
Soil Type (*2)	4	sands and silts
Velocity (*2)	1	1.5 ft/s
Wave Action (Wind/Boat)	3	moderate wind waves
Economic Factor (*2)	2	town of Knights Landing
Human Usage	1	occassional
Seepage Potential	0	no known seepage history
Tidal Fluctuation	0	not tidally influenced
Erosion Hazard	44	Calculate Erosion Hazard

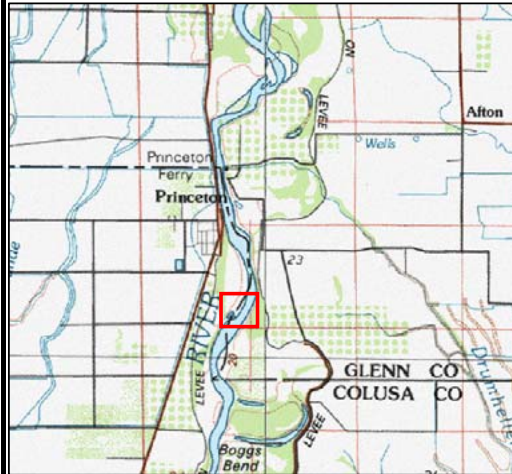
Site Location Map

Sacramento River, RM 163.0L

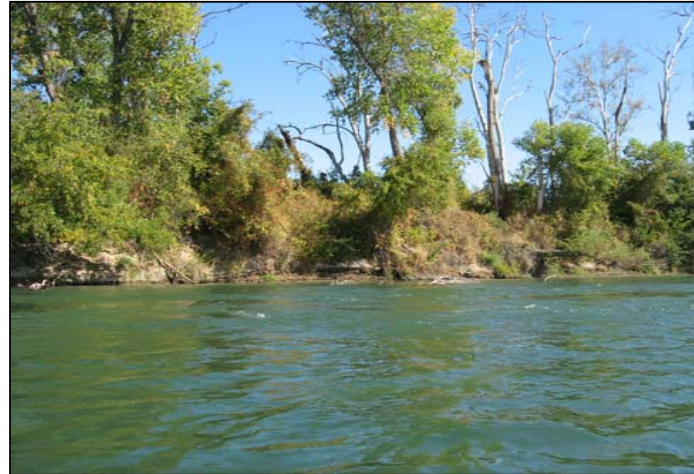
Site Photograph

Criteria	Score	Notes
Bank Slope (*2)	3	1.5:1 slope
Berm Width (*2) - Estimated	0	60 ft
Length of erosion	4	1194 ft
Location of erosion	2	full bank
Bank Stability	2	vertical sections, less than half bank height
Radius of Curvature (R_c/w)	0	$R/w = 5.62$
Site Relative to Bend	3	outside of a gentle bend
Geomorph	2	migration possible on opposite bank
Vegetation Cover	0	80%
Tree Hazard	4	large trees with exposed roots
Soil Type (*2)	2	clays and silts
Velocity (*2)	5	10.07 ft/s
Wave Action (Wind/Boat)	2	low
Economic Factor (*2)	2	small town of Butte City
Human Usage	0	rare
Seepage Potential	0	no seepage history
Tidal Fluctuation	0	no tidal influence
Erosion Hazard	43	Calculate Erosion Hazard

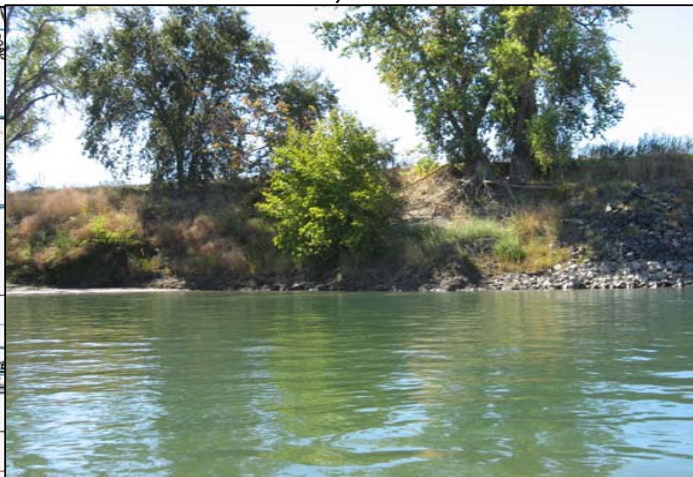
Site Photograph

Criteria	Score	Notes
Bank Slope (*2)	2	2:1 slope
Berm Width (*2) - Estimated	0	40 ft
Length of erosion	2	263 ft
Location of erosion	4	lower bank and toe
Bank Stability	4	vertical sections greater than half bank height
Radius of Curvature (R_c/w)	1	$R/w = 4.9$
Site Relative to Bend	0	inside of a bend
Geomorph	0	no migration possible
Vegetation Cover	2	40%
Tree Hazard	5	large trees, exposed roots and leaning
Soil Type (*2)	2	clays and silts
Velocity (*2)	4	5.01 ft/s
Wave Action (Wind/Boat)	2	moderate
Economic Factor (*2)	2	small town of Grimes
Human Usage	3	monthly
Seepage Potential	0	no seepage history
Tidal Fluctuation	0	no tidal influence
Erosion Hazard	43	Calculate Erosion Hazard

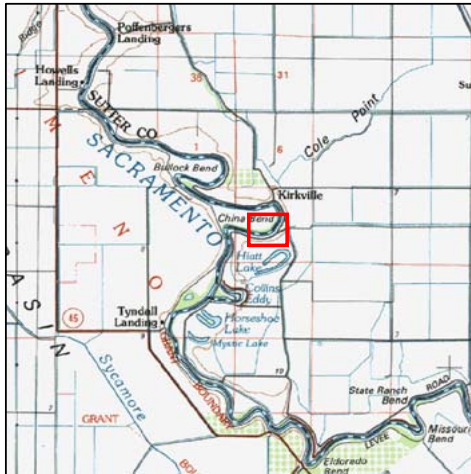
Site Location Map

Sacramento River, RM 104.0L

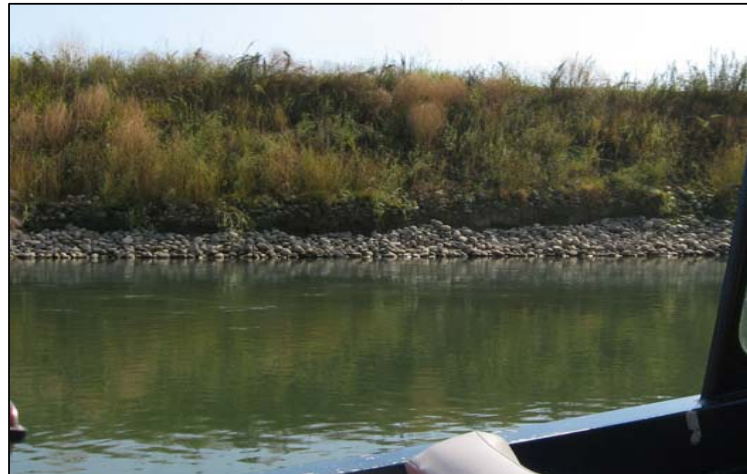
Site Photograph

Criteria	Score	Notes
Bank Slope (*2)	3	1.5:1 slope
Berm Width (*2) - Estimated	0	35 ft
Length of erosion	5	3012 ft
Location of erosion	4	levee, and berm
Bank Stability	2	vertical sections, less than half bank height
Radius of Curvature (R_c/w)	2	$R/w = 3.54$
Site Relative to Bend	4	outside of a 90 degree bend
Geomorph	2	migration possible on opposite bank
Vegetation Cover	1	60% to 70%
Tree Hazard	0	no trees
Soil Type (*2)	4	sands and silts
Velocity (*2)	2	2.25 ft/s
Wave Action (Wind/Boat)	2	moderate
Economic Factor (*2)	1	Farms
Human Usage	1	occassional
Seepage Potential	0	no seepage history
Tidal Fluctuation	0	no tidal influence
Erosion Hazard	43	Calculate Erosion Hazard

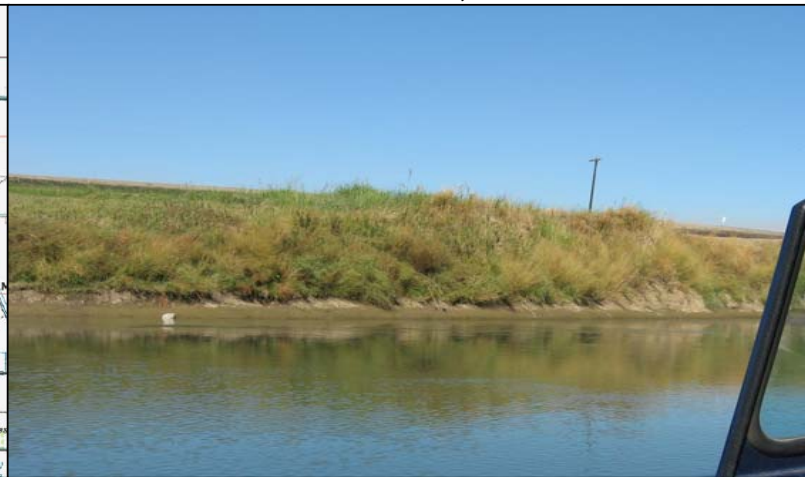
Site Photograph

Criteria	Score	Notes
Bank Slope (*2)	4	1:1 slope
Berm Width (*2) - Estimated	0	30 ft
Length of erosion	4	1268 ft
Location of erosion	4	full bank and toe
Bank Stability	5	vertical sections and caves
Radius of Curvature (R_c/w)	0	relatively straight
Site Relative to Bend	1	relatively straight
Geomorph	0	no migration expected
Vegetation Cover	3	30 - 40%
Tree Hazard	0	no trees
Soil Type (*2)	4	sands and silts
Velocity (*2)	3	3.23 ft/s
Wave Action (Wind/Boat)	2	moderate
Economic Factor (*2)	1	Farms
Human Usage	0	rare, too steep
Seepage Potential	0	no seepage history
Tidal Fluctuation	0	no tidal influence
Erosion Hazard	43	Calculate Erosion Hazard

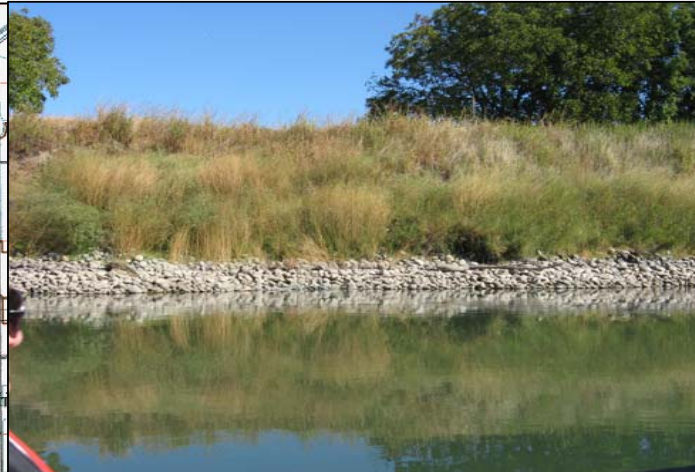
Site Photograph

Criteria	Score	Notes
Bank Slope (*2)	3	1.5:1 slope
Berm Width (*2) - Estimated	0	30 to 50 ft
Length of erosion	5	2824 ft
Location of erosion	3	toe
Bank Stability	5	vertical sections less than half bank height and caves
Radius of Curvature (R_c/w)	0	$R/w = 6.18$
Site Relative to Bend	3	outside of a gentle bend
Geomorph	0	no migration expected
Vegetation Cover	2	about 50%
Tree Hazard	0	no trees on bank
Soil Type (*2)	4	sands and silts
Velocity (*2)	3	3.35 ft/s
Wave Action (Wind/Boat)	2	moderate
Economic Factor (*2)	1	Farms
Human Usage	1	occassional
Seepage Potential	0	no seepage history
Tidal Fluctuation	0	no tidal influence
Erosion Hazard	43	Calculate Erosion Hazard

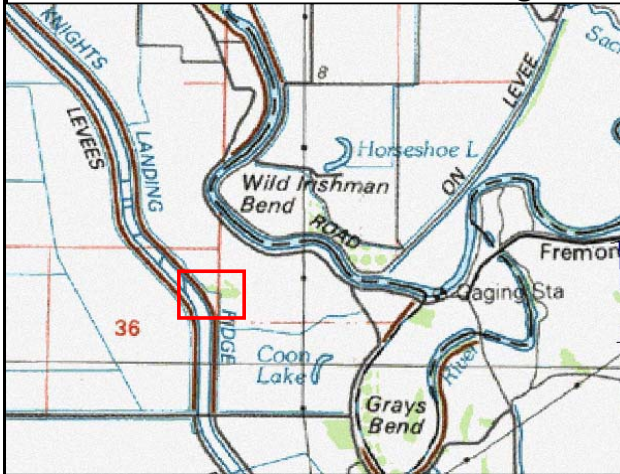
Site Location Map

Knights Landing Ridge Cut, LM 3.1 (KLRD Unit 2 East)

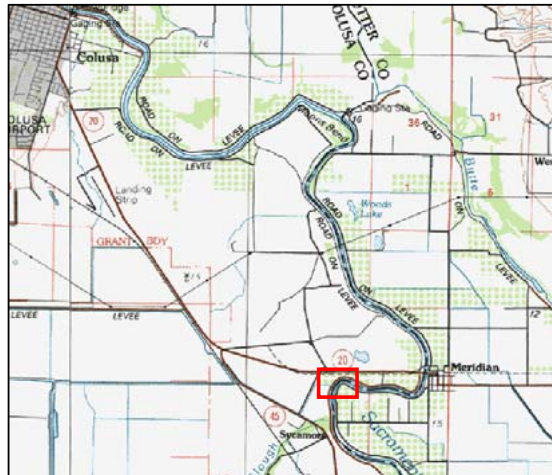
Site Location Map

Sacramento River, RM 132.9R
